## City of Alexandria Storm Sewer Capacity Analysis (CASSCA)

### Cameron Run Condition Assessment

**PREPARED BY:** Michael Baker Jr., Inc.

**DATE:** November 4, 2014 (Revised May 26, 2015)

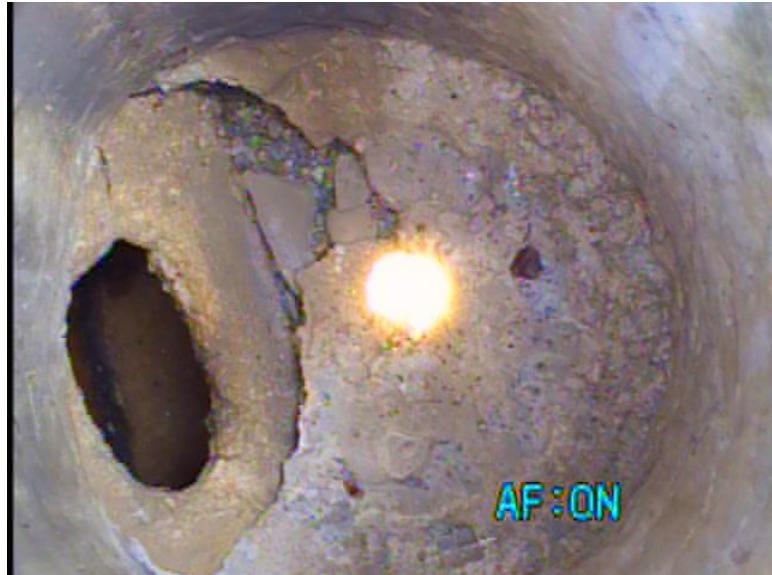
The majority of problems found in the structures were associated with the chamber areas. There were over 600 instances of minimum-severity defects in the chambers of the inspected structures, and 29 moderate-severity defects in the chambers. Cracks in the chamber between 1/16" to 1/8" in width, for example, are considered moderate damage. Corroded, pitted or spalled portions of a structure are also considered damage; for example, 10-25% of material loss classifies the damage as moderate. Figure 4 and 5 are examples of moderate damage to the chamber walls.

**Figure 4. Moderate Damage to Chamber Wall in Structure 001162IN  
(Overall SCREAM Score = 50).**

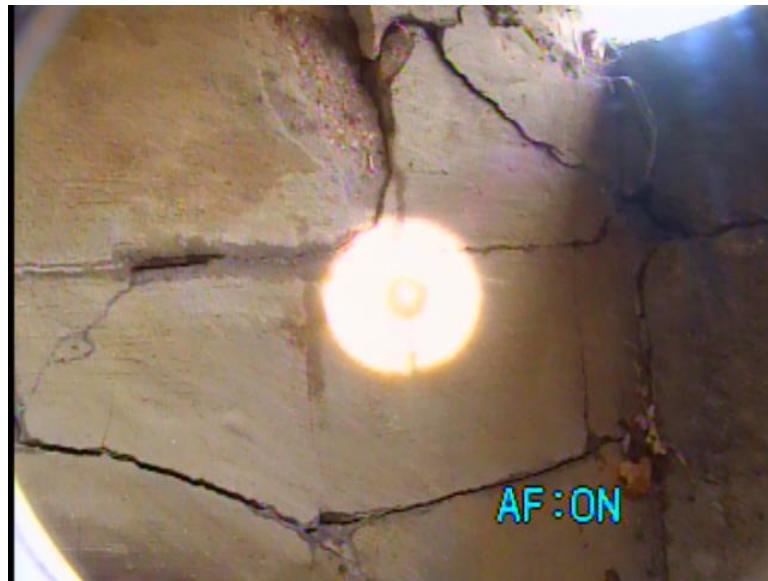
**Figure 5. Moderate Damage to Chamber Wall in Structure 001496IN  
(Overall SCREAM Score = 50).**

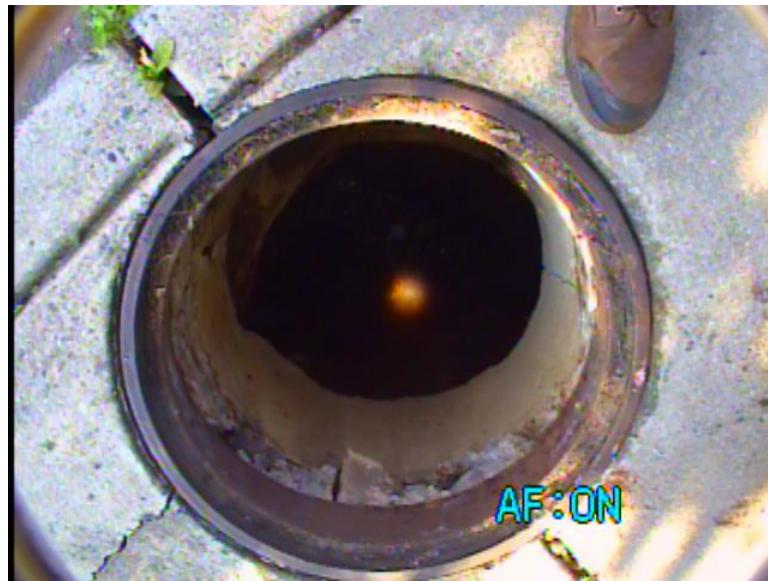
Examples of problems in the major category for the frame base seal, and frame are shown in Figures 6 and 7, respectively.

**Figure 6. Major Frame Base Seal Damage on Structure 000485SMH  
(Overall SCREAM Score = 64).**

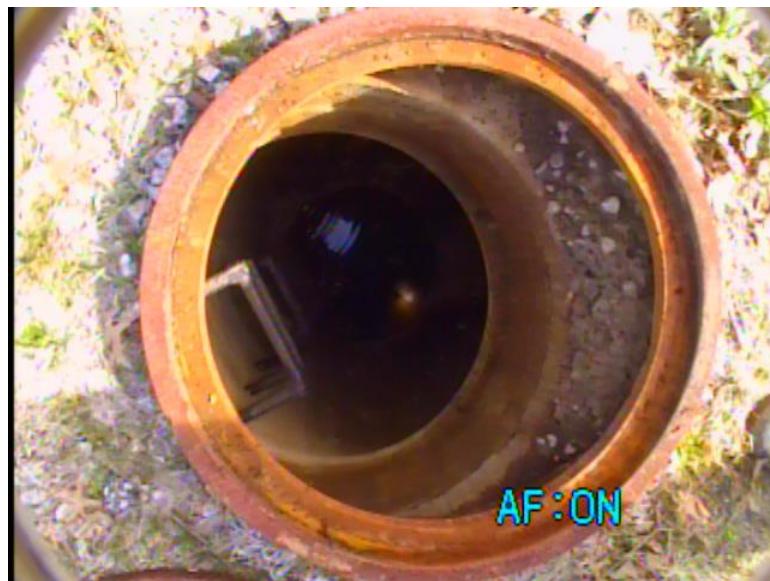
**Figure 7. Major Frame Offset on Structure 000221IN  
(Overall SCREAM Score = 50).**

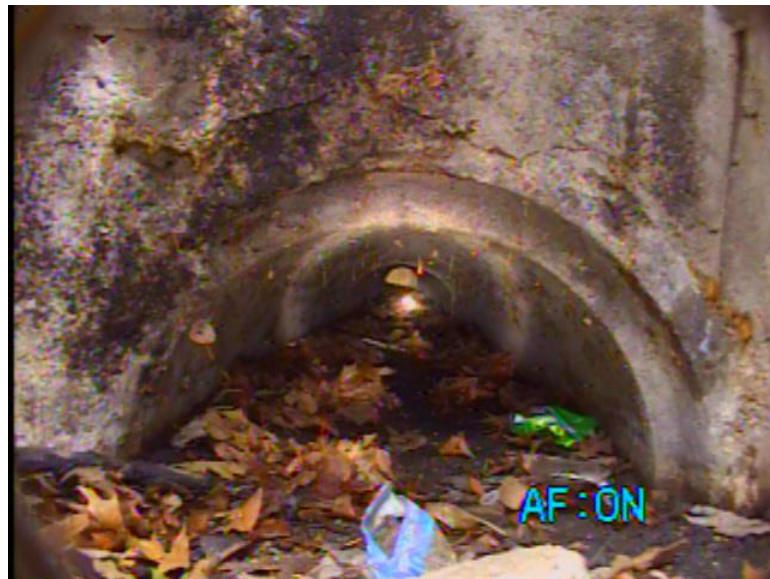
The problems in the component extreme category were associated with the manhole channel (7 instances), bench (4 instances), and pipe connections (1 instance). Generally, this involved either large amounts of settled debris (more than about five gallons), large cracks in the concrete (larger than  $\frac{1}{4}$  inch), or spalling and etching (25% to 50% material loss). Infiltration associated with the cracks (inflow higher than about 10 gpm) is also ranked in the extreme category of defects. Figures 8 and 9 are examples of problems in the extreme category in manhole channels. Figure 10 depicts an extreme example of a manhole pipe connection problem.

**Figure 8. Heavy Debris in Structure 002451IN  
(Overall SCREAM Score = 69).**

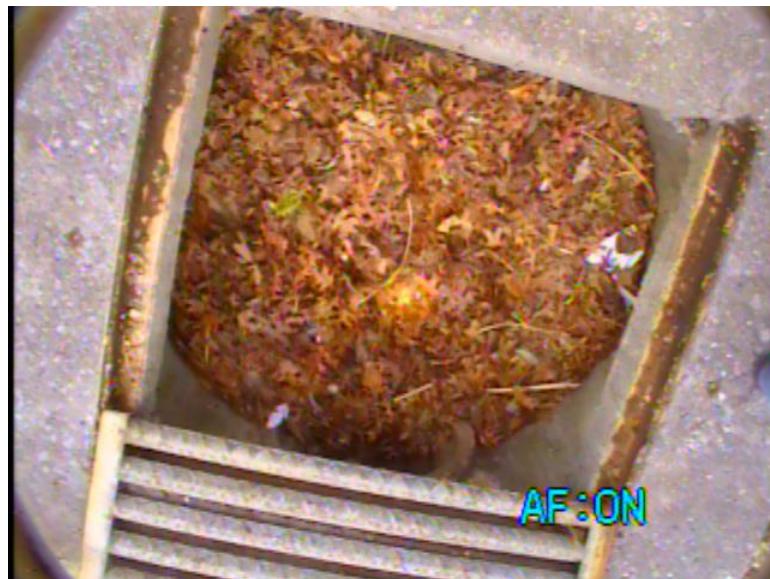
**Figure 9. Heavy Debris in Structure 000059CB  
(Overall SCREAM Score = 69).**

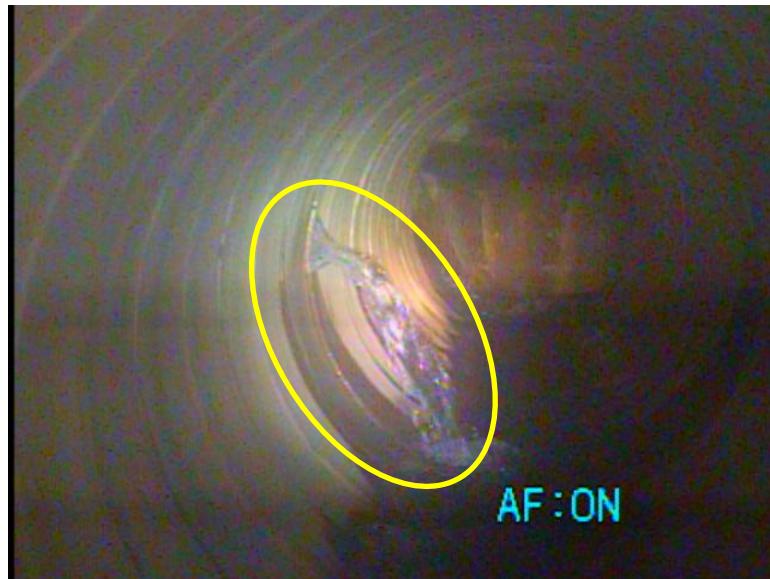
**Figure 10. Infiltration at Pipe Connection in Structure 000856SMH  
(Overall SCREAM Score = 61).**

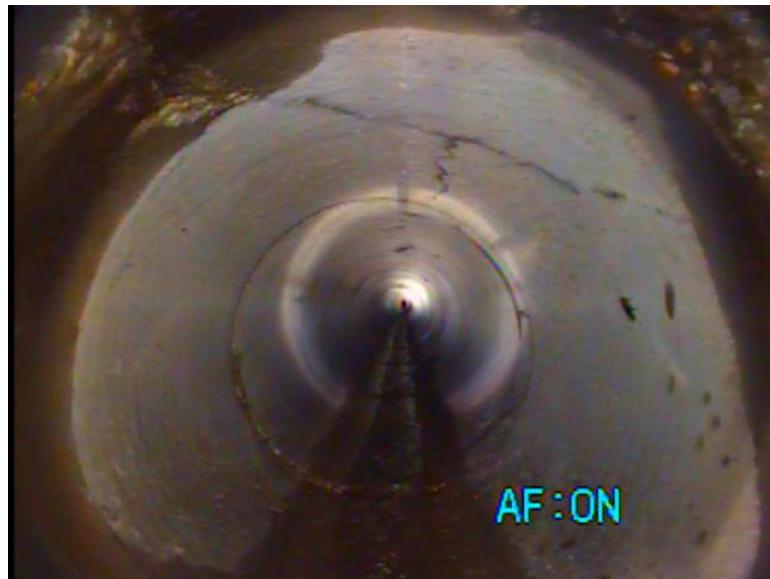
The following images captured during the lamping inspections show typical defects observed within Cameron Run storm pipes. Figures 13 and 14 show examples of structural damage, both with multiple long cracks throughout the storm pipe. The 18-inch diameter segment in Figure 13 and the 36-inch diameter segment in Figure 14 both had overall SCREAM scores of 40 (minimum). Figure 15 is an example of an open joint in a 21-inch pipe with a SCREAM score of 30 (minimum). Figure 16 shows evidence of infiltration inside a 66-inch pipe placing it in the few observed defects category with a SCREAM score of 20.

**Figure 13. Multiple Cracks in 18-in Storm Pipe between Structures 000853SMH and 000854SMH  
(Overall SCREAM Score = 40).**

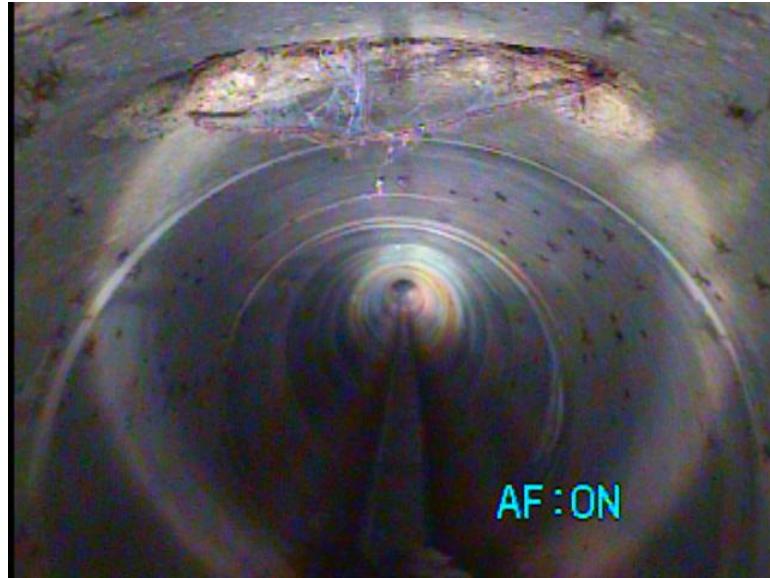
**Figure 14. Multiple Cracks in 36-in Storm Pipe between Structures 001495IN and 001500IN  
(Overall SCREAM Score = 40).**

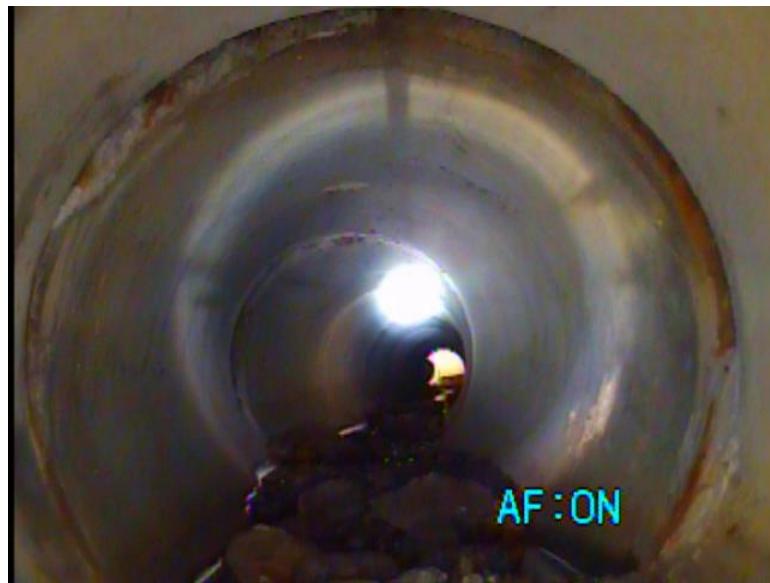
**Figure 15. Open Joint in 21-in Storm Pipe between Structures 003626IN and 003624IN  
(Overall SCREAM Score = 30).**

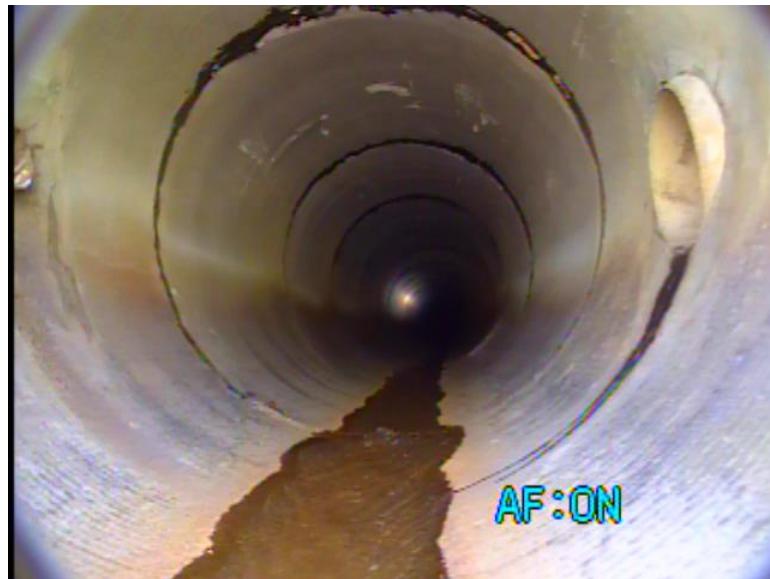
**Figure 16. Infiltration in 66-in Storm Pipe between Structures 001175SMH and 000230IO  
(Overall SCREAM Score = 20).**
